4. TITLE (and Subtitle) National Program of Inspection of Non-Federal Dams Tennessee. Marys Creek Dam No. 9 (Inventory Number TN 15739) near Cross Roads, TN., Shelby County, TN., Wolf River Basin	5. TYPE OF REPORT & PERIOD COVERED Phase 1 Investigation Report

PHASE I INSPECTION REPORT
NATIONAL DAM SAFETY PROGRAM
TENNESSEE

Name of Dam Mary's Creek Watershed Dam No. 9
County Shelby
Stream Unnamed Tributary of Mary's Creek
Date of Inspection March 11, 1981

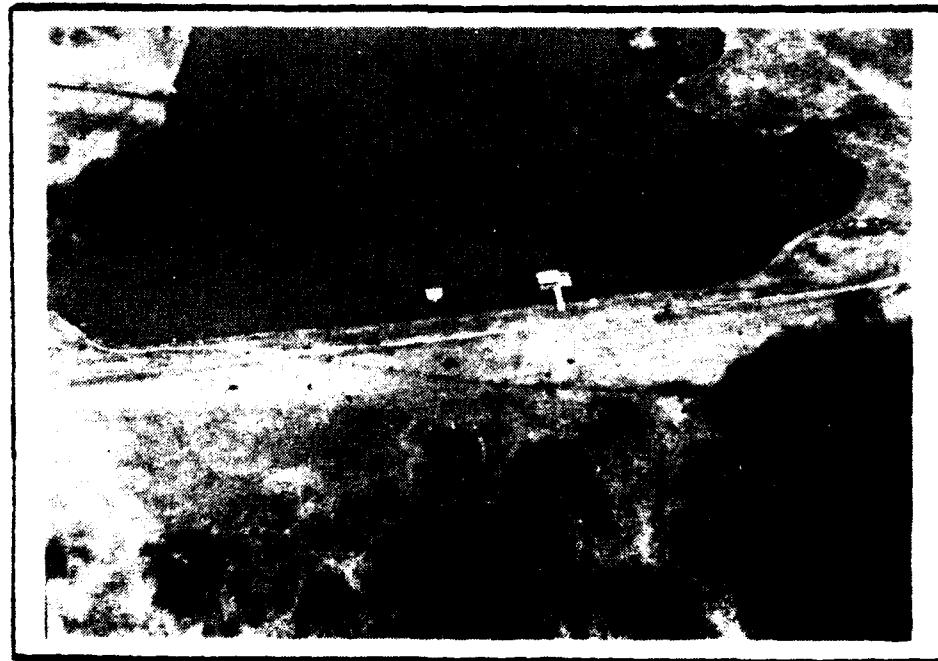
PHOTO NO. 12

3.1.1 Embankment - The dam is well grassed and virtually free of undesirable vegetation. It has a uniform cross-section and well defined boundaries. There were no indications of seepage or structural instabilities observed; no cracking, heaving, or slides. Erosion is minor with some loss of cover along the principal cattle trail traversing the dam.

- Photo No. 1 - Lake and dam from upstream left.
- Photo No. 2 - Upstream slope of dam left of center.
- Photo No. 3 - Upstream slope from right end of dam.
- Photo No. 4 - Downstream slope of dam from emergency spillway exit channel.
- Photo No. 5 - Minor erosion along upstream slope of dam right of center.
- Photo No. 6 - Riser from dam crest.
- Photo No. 7 - Emergency spillway entrance channel from dam centerline.
- Photo No. 8 - Principal spillway outlet.
- Photo No. 9 - Downstream channel and plunge pool.
- Photo No. 10 - Dam crest showing location of soil sample hole and emergency spillway in background.
- Photo No. 11 - Aerial view of lake and dam showing small upstream lake.
- Photo No. 12 - Aerial view of dam showing cattle on embankment.

- 2) develop an emergency action plan to warn down-stream residents in the event a serious problem develops with the dam.
- 3) control cattle grazing to minimize damage to the embankment.
